# Planting Stormwater Ponds: Determining the Benefits and Best Management Practices for Ornamental Plants in an Underutilized Portion of Residential Landscapes

Basil Iannone, UF/IFAS Forest Resources and Conservation, [biannone@ufl.edu](mailto:biannone@ufl.edu)  
Michelle Atkinson, UF/IFAS Extension Manatee County, [michelleatkinson@ufl.edu](mailto:michelleatkinson@ufl.edu)  
Mary Lusk, UF/IFAS Soil and Water Sciences, [mary.lusk@ufl.edu](mailto:mary.lusk@ufl.edu)

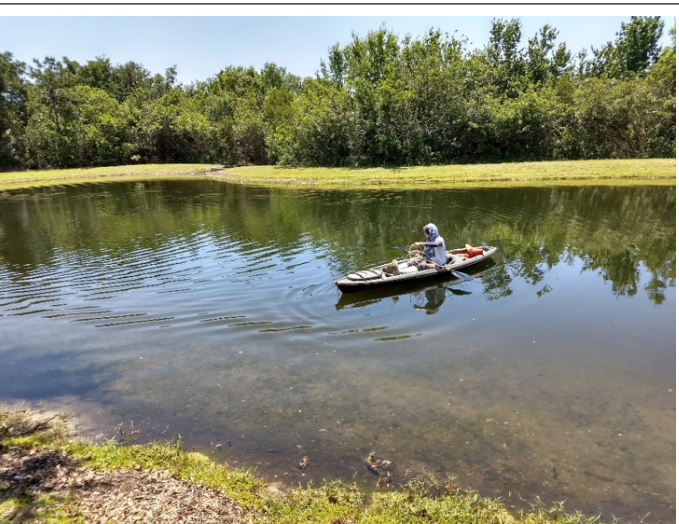
**Fig. 1. Dr. Jariani Mohd-Jani assisting with baseline sampling of LWR SWPs.**

LWR IDA donated over \$16,000 to cover planting costs. Prior to planting, our team quantified concentrations of inorganic and organic nutrients, water clarity, and the amount of bank erosion for all 12 studied SWPs (Fig. 1). We will sample one more time prior to October 2018 and once during the winter of 2018-2019. We will begin more frequent sampling after plant establishment during the spring/summer of 2019. We are more likely to detect effects of plants on water quality and bank stabilization after this establishment period.

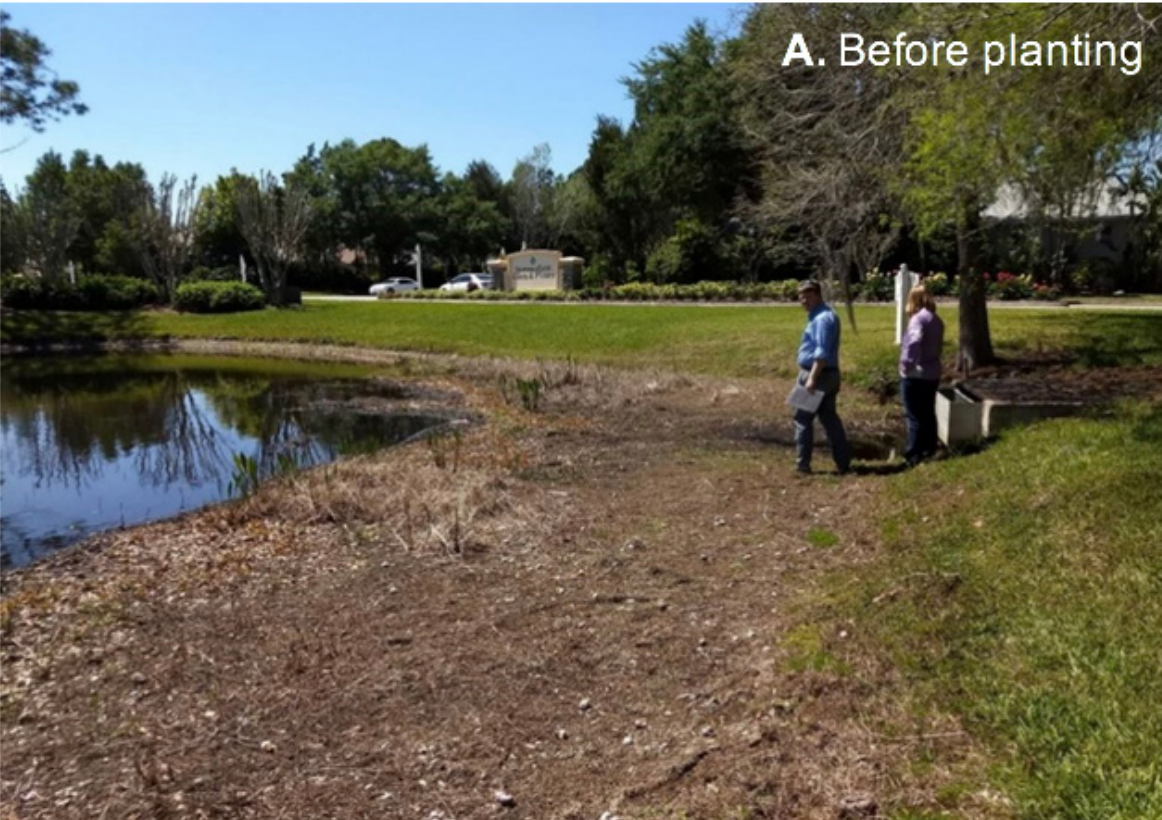
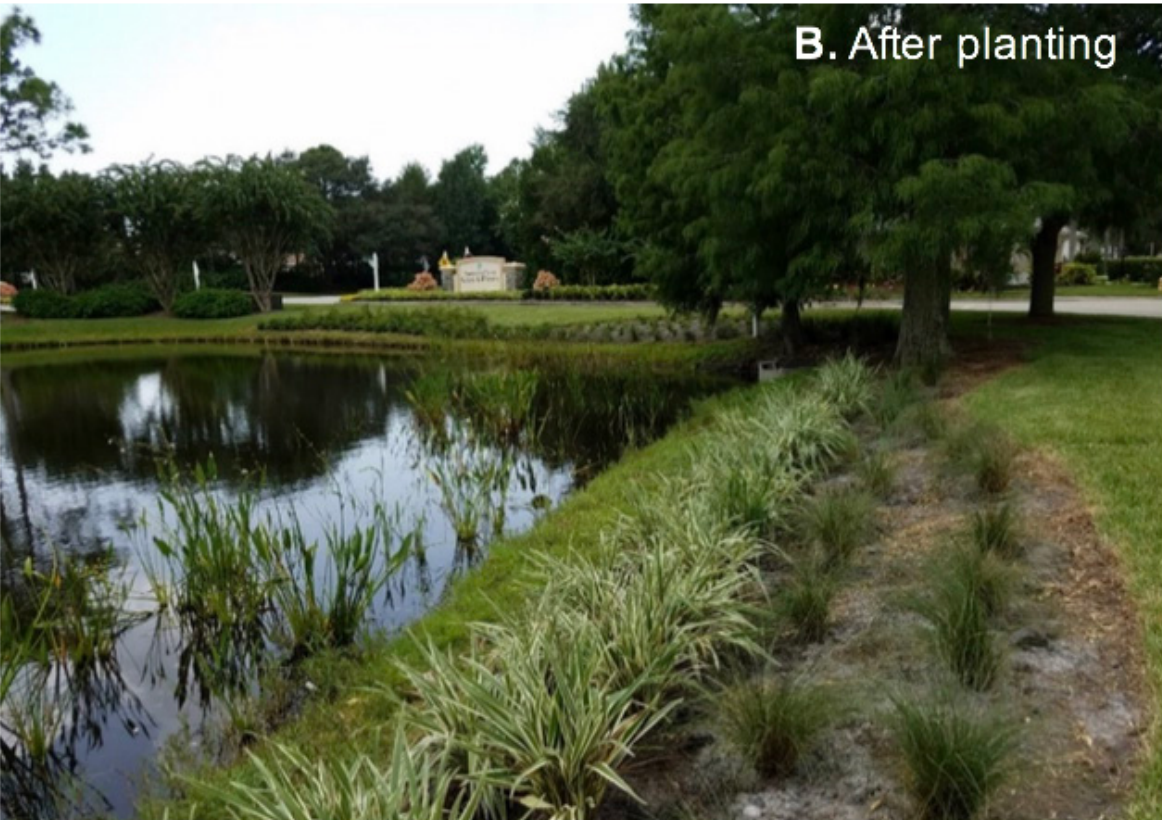
Fig. 3. Before (A) and after (B) planting images of SWP in LWR illustrating initial improvements in aesthetics. Dr. Eban Bean and Dr. Mary Lusk (from left to right) are shown in A.

Plantings of SWP banks and littoral shelves were completed by mid-August. Again, the costs of the plant materials and installation was provided by LWR IDA. UF/IFAS also provided about 76 hours-worth of labor to these efforts (Fig. 2). As of now, it looks as if plantings are doing well (Fig. 3). Although, some littoral plantings are exhibiting damage and stress from what appears to be some form of herbivory. Altec has agreed to address this concern.
